GEOLOGICAL ISSUES

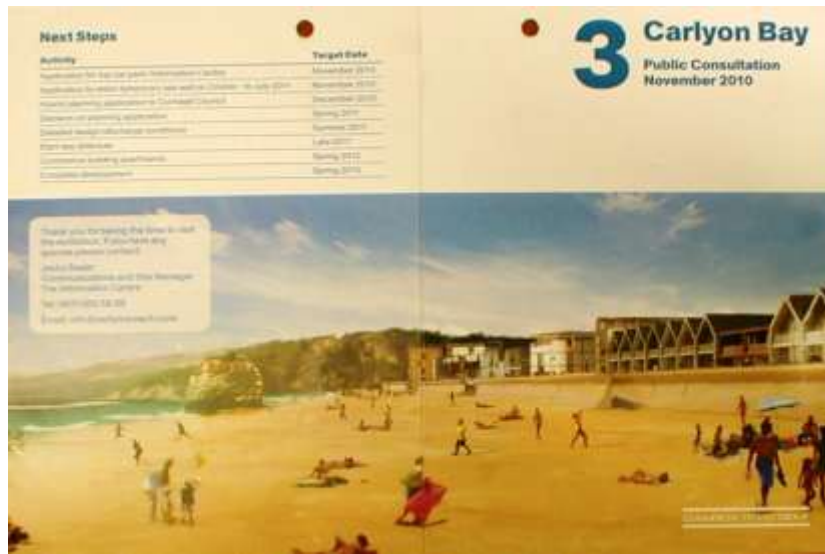
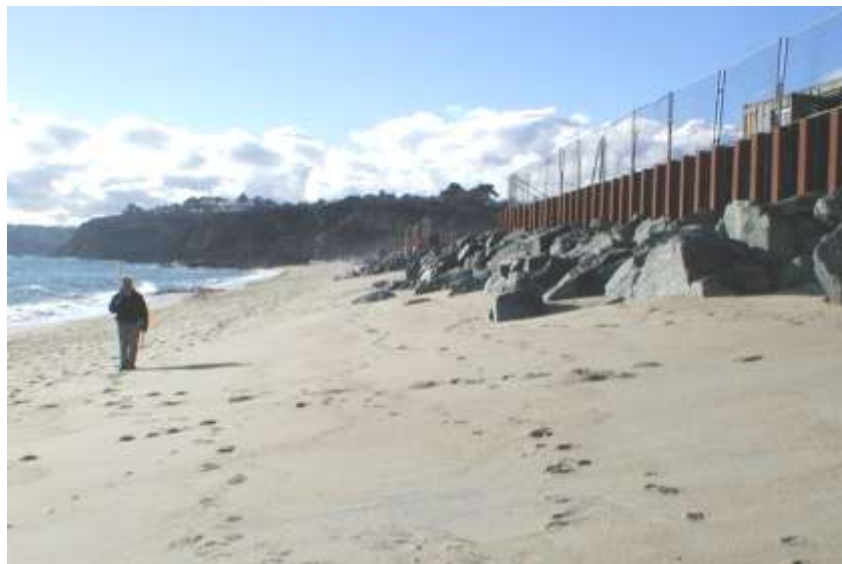
1.42.

- 1.43 This point is very easily identified by reference to the above two photographs where, in order to achieve the necessary 9.2 metre height, the 'toe' of the new primary wall as seen in the first picture would need to be set at the height of the top-edge of the unauthorised steel shuttering shown in the second picture.
- 1.44 With the benefit of many years of close observation, I can further state that because of the angular structure of stent particles, in order to maintain the intended beach profile, frequent recharges would become essential, especially after storms.

- 1.40. The design of the sea defence works requires nourishment to maintain the beach width and protection for the rock armour
- 1.41. It is abundantly self-evident that there is not the slightest prospect of the developer being able to achieve the indicated beach profile without a very substantial quantity of matching 'stent' being imported. Based upon available data, including the fact that the finished height of the new primary sea wall is to be **9.2 metres** above OS datum, and based upon my long-established knowledge of the high degree of mobility associated with the beaches at Carlyon Bay, I estimate this quantity to be at least a million tonnes but that figure does not take into account the substantial but necessary 'infills' behind the sea wall once the undercroft has been constructed.
